## Test Report

### Verification of mooring bollards at

Port of XXXX XXXXX, France

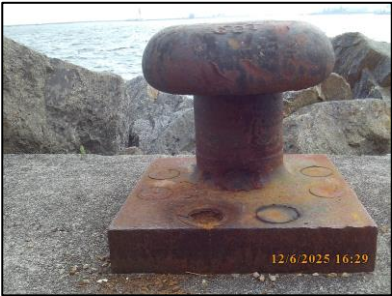
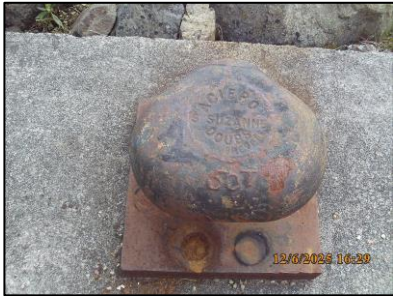
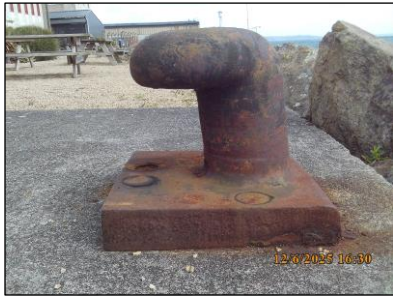
7.1 Bollard 01

| ASA Brest | | | | | | | | Stiffness | Acc1 | Acc2 | Acc3 |
|---|---|---|---|---|---|---|---|---|---|---|---|
| 1 | T Head | UNK | 100 | | 0 | 10 | 293.8 | 2.2 | 7.4 | 5.1 | 29.9 |

PASS

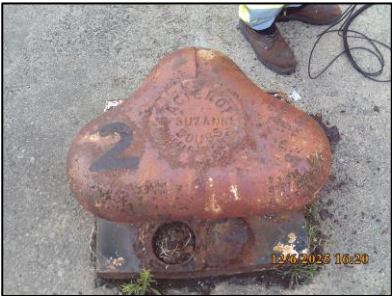
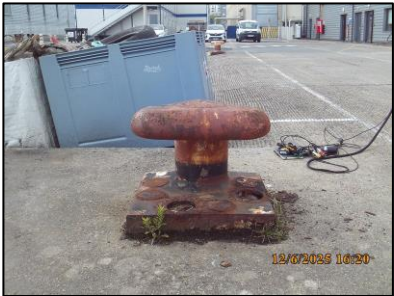
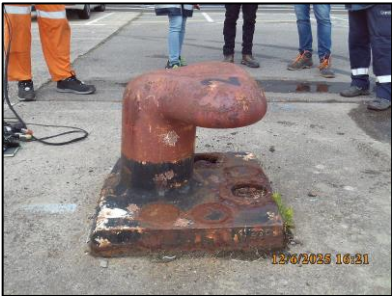
## 7.2 Bollard 02

| ASA Brest | | | | | | | | Stiffness | Acc1 | Acc2 | Acc3 | |
|---|---|---|---|---|---|---|---|---|---|---|---|---|
| 2 | T Head | UNK | 75 | | 0 | 10.3 | 212.5 | 2.6 | 3.1 | 10.2 | 27.4 | 16.8 |

PASS

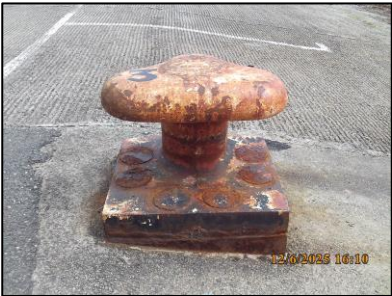
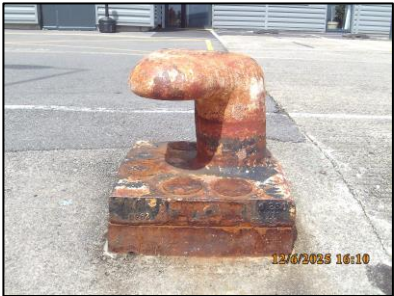
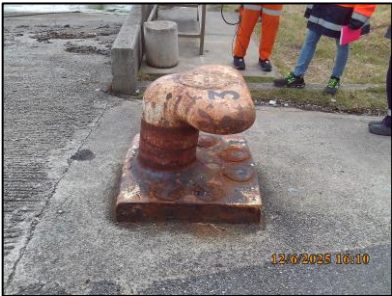
## 7.3 Bollard 03

| ASA Brest | | | | | | | | Stiffness | Acc1 | Acc2 | Acc3 | |
|---|---|---|---|---|---|---|---|---|---|---|---|---|
| 3 | T Head | UNK | 75 | | 0 | 10.6 | 212.5 | 3.5 | 3.8 | 8.6 | 32.9 | 16.4 |

PASS

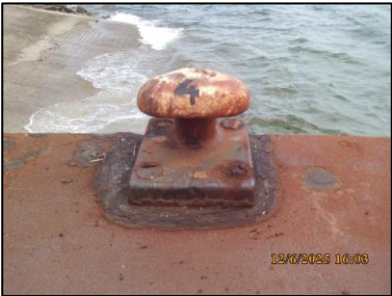
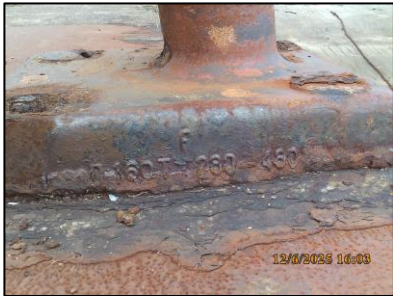
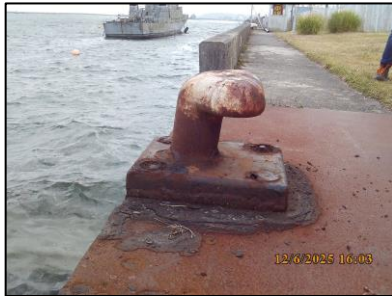
7.4 Bollard 04

- 9 bollards (Nos. 1, 2, 3, 5, 6, 7, 8, 9, and 10) received a “PASS” rating, confirming their eligibility for insurance certification, provided a maintenance plan is established and followed.
- 1 bollard (No. 4) was rated “PENDING”, due to concerns over its mounting system—specifically, a lack of clear anchorage to the quay wall. While it can be used with caution, further inspection and possible remedial actions are recommended.

The bollards are deemed fit for the planned operation with the exemption of bollard 4. This bollard is mounted on a steel plate which has no obvious connection to the quay wall.

| ASA Brest | | | | | | | | | Stiffness | Acc1 | Acc2 | Acc3 |
|---|---|---|---|---|---|---|---|---|---|---|---|---|
| 4 | T Head | UNK | 35 | | 0 | 11.7 | 250 | 5.4 | 0.5 | 22.1 | 113.6 | 15.2 |

PENDING

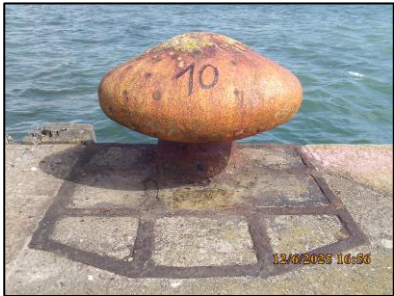
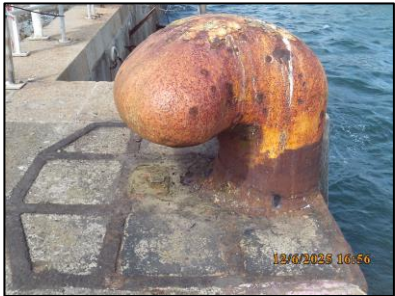
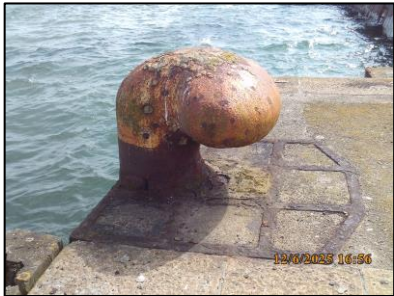
## 7.10 Bollard 10

| ASA Brest | | | | | | | | Stiffness | Acc1 | Acc2 | Acc3 | |
|---|---|---|---|---|---|---|---|---|---|---|---|---|
| 10 | T Head | UNK | 100 | | 0 | 11 | 212.5 | 10.8 | 15.9 | 13.2 | 98.5 | 20.6 |

PASS
