## Test Report

### Verification of mooring bollards at

Port of XXXX XXXXX, France

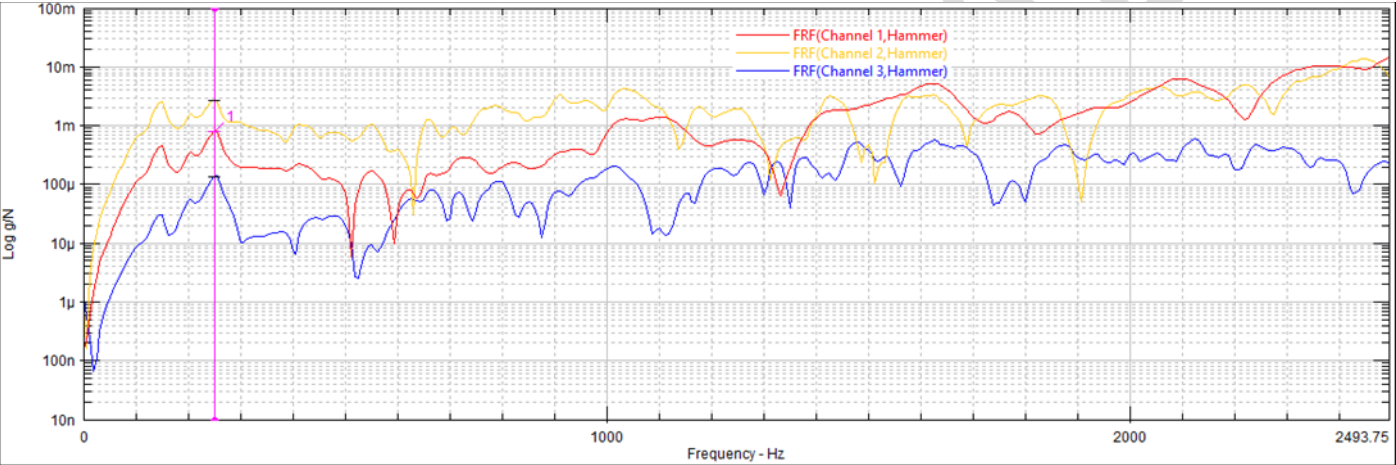
7.4.2 Graph

- 9 bollards (Nos. 1, 2, 3, 5, 6, 7, 8, 9, and 10) received a “PASS” rating, confirming their eligibility for insurance certification, provided a maintenance plan is established and followed.
- 1 bollard (No. 4) was rated “PENDING”, due to concerns over its mounting system—specifically, a lack of clear anchorage to the quay wall. While it can be used with caution, further inspection and possible remedial actions are recommended.
